**Flood Control Project Maintenance  
Levee Inspections**

**2018 Channel Summary Report**

**Madera County FCWCA**

**Ash Slough**

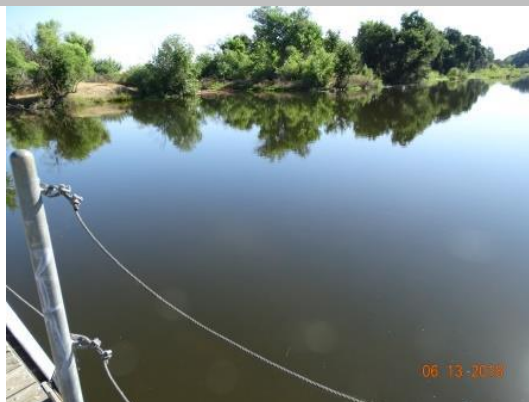
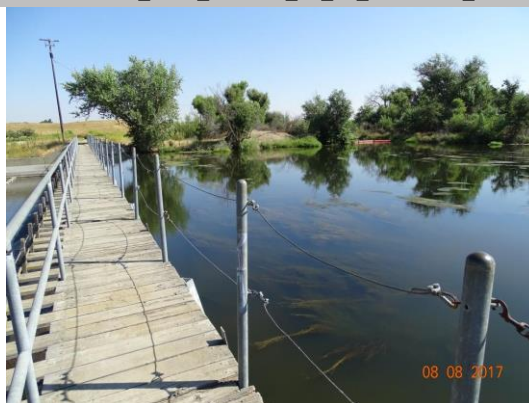
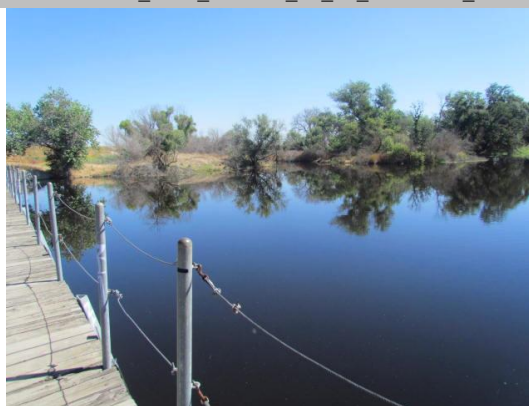
View of the channel looking upstream of the low water crossing. (2018)

View of the channel looking upstream of the low water crossing.  
Summer 2017

Looking east (upstream) of structure on Ash Slough.

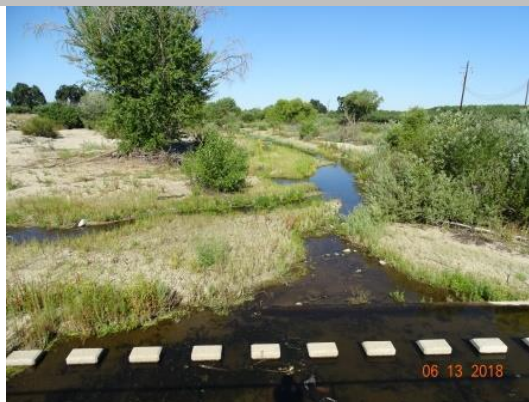
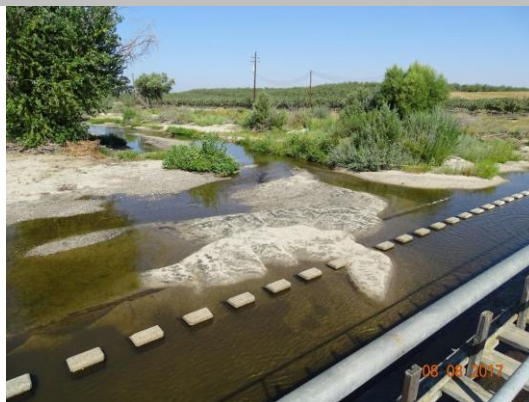
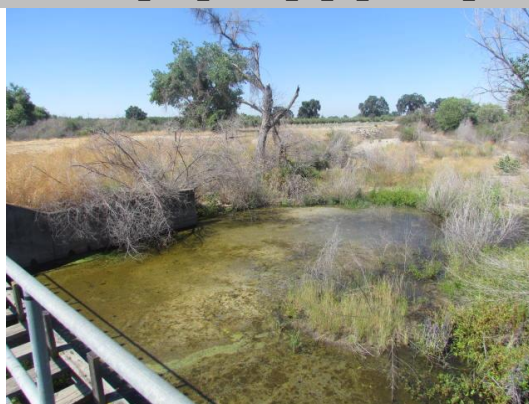
Check Point / View				
Low Water Crossing / Down				
Rating **	A	Issue No.	91	GPS Lat/Long
Issue Type +	Ma	Location *		37.158592 °
Category	Rivers, Channels & Designated Flood			-120.124551 °
Item	Vegetation & Obstructions			
DWR ID	DWR_NA0011_38_c_2012_91			
Action/Comments				
Inspector Comments: Some vegetation present but does not appear to impede flow in the channel at this time.

View of the channel looking downstream from the low water crossing. (2018)

View of the channel looking downstream from the low water crossing.  
Summer 2017

Looking west (downstream) at channel from low water crossing.

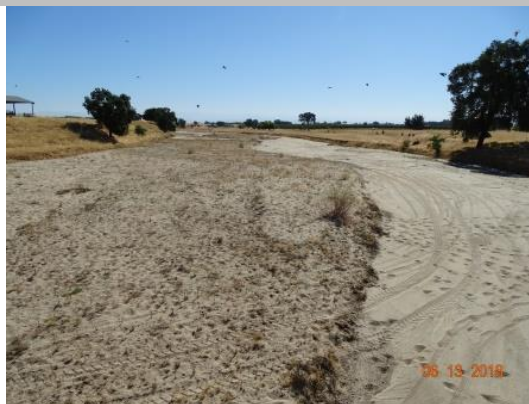
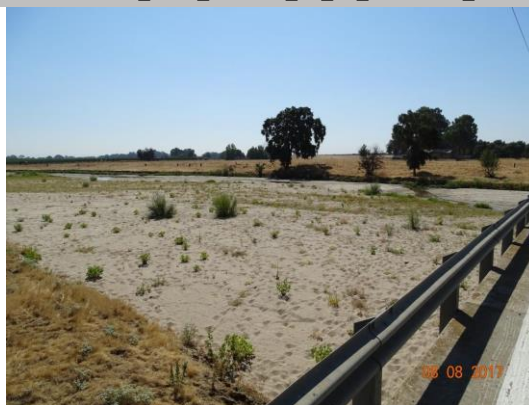
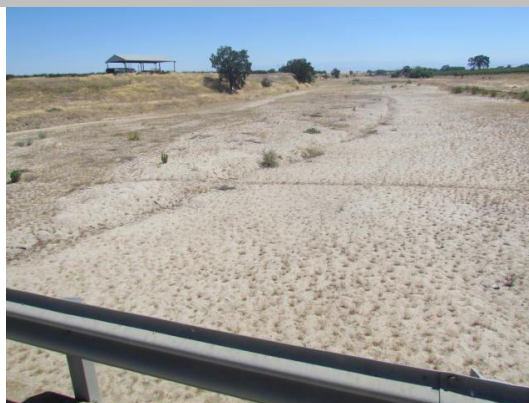
Looking upstream at the channel. (2018)

View of the channel looking upstream. Summer 2017

Looking east (upstream) at channel from Santa Fe Dr.

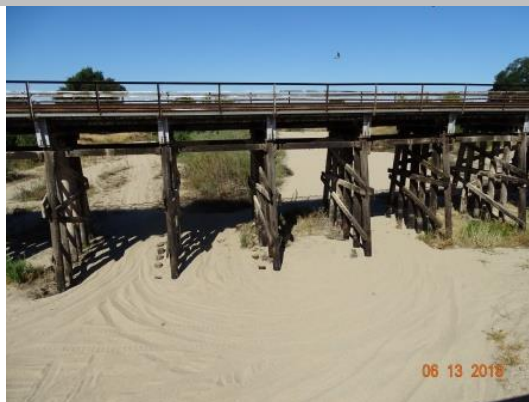
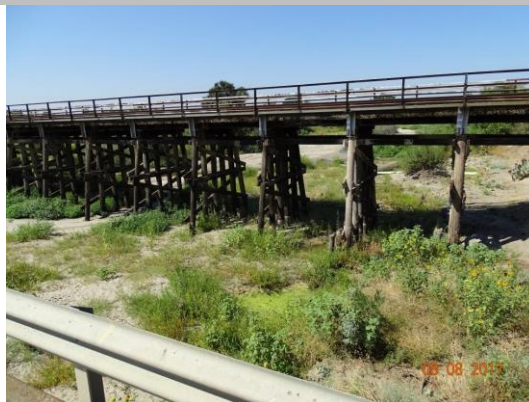
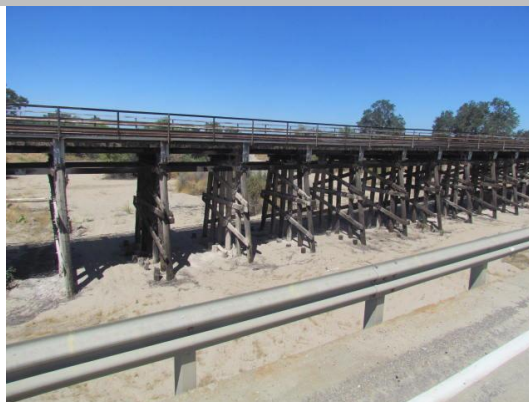
Rating **	A	Issue No.	16	GPS Lat/Long
Issue Type +	Ma	Location *		37.146700 °
Category	Rivers, Channels & Designated Flood			-120.164240 °
Item	Vegetation & Obstructions			
DWR ID	DWR_NA0011_38_c_2012_16			
Action/Comments				
Inspector Comments: No vegetation or obstructions present to impede flow.

Looking downstream at the channel. (2018)

View of the channel looking downstream during summer 2017 inspection.

Looking northwest (downstream) at channel from Santa Fe Dr.

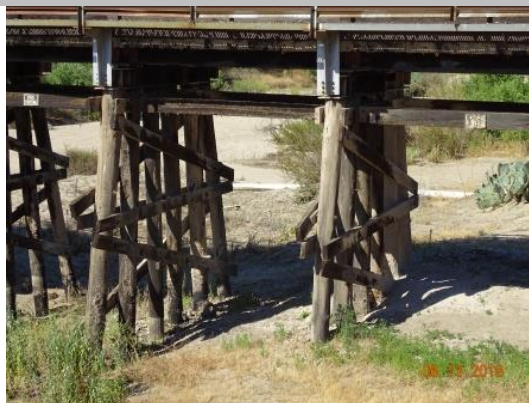
Inspector Comments: Pvc pipe going under the channel. It does not appear to impede flow or emergency operations.

View downstream of pvc pipe going under the channel. (2018)

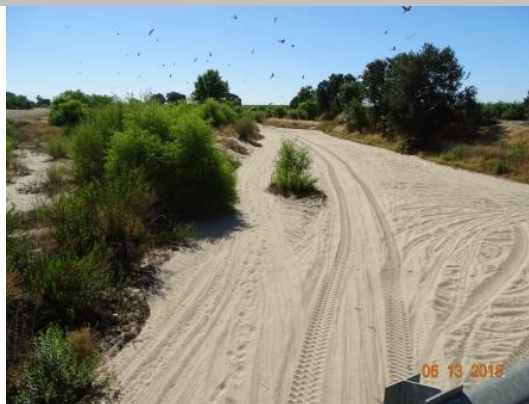
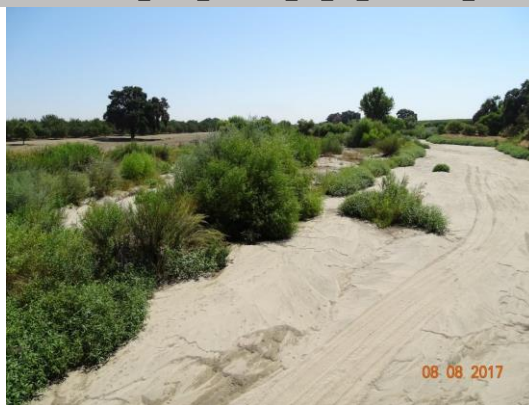
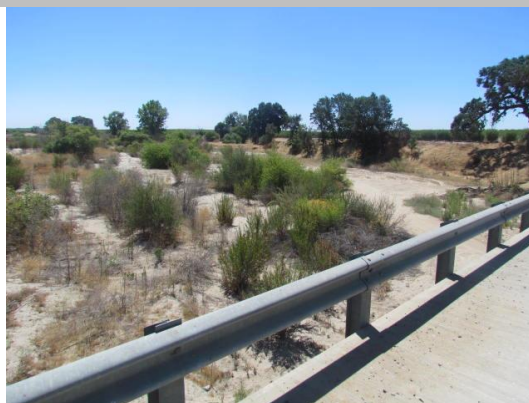
View of the channel looking upstream. (2018)

View of the channel looking upstream during 2017 inspection.

Looking east (upstream) at channel from Rd. 19.

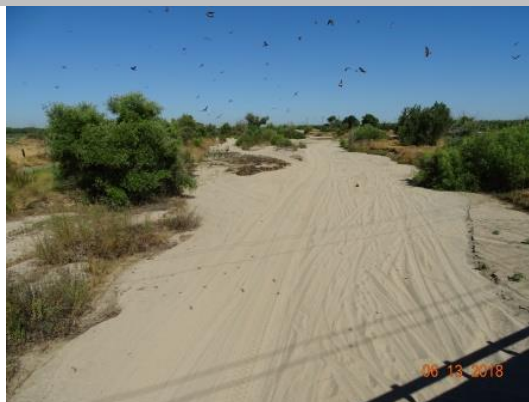
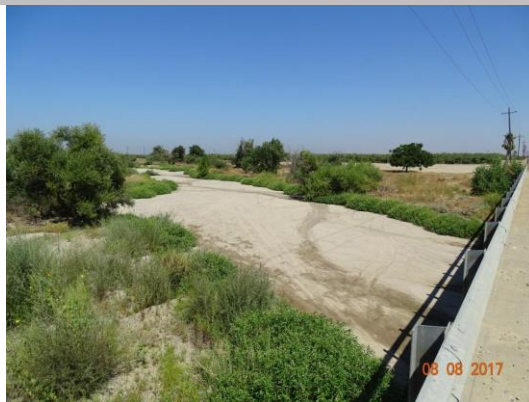
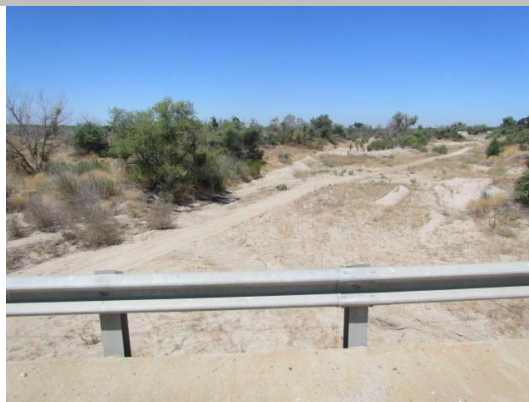
Check Point / View				
Rd 19 / Down				
Rating **	A	Issue No.	26	GPS Lat/Long
Issue Type +	Ma	Location *		37.138373 °
Category	Rivers, Channels & Designated Flood			-120.202057 °
Item	Vegetation & Obstructions			
DWR ID	DWR_NA0011_38_c_2012_26			
Action/Comments				
Inspector Comments: Some vegetation present but does not appear to impede flow.

View of the channel looking downstream. (2018)

View of the channel looking downstream. Summer 2017

Looking west (downstream) at channel from Rd. 19. (2016)

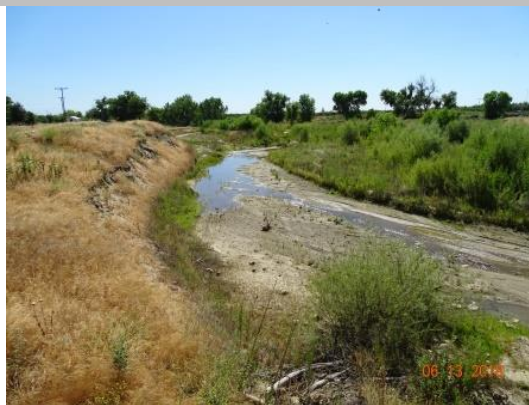
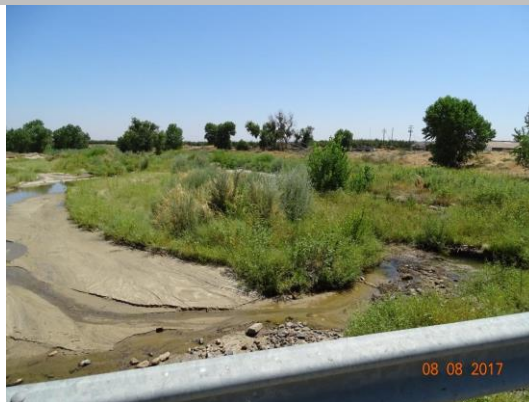
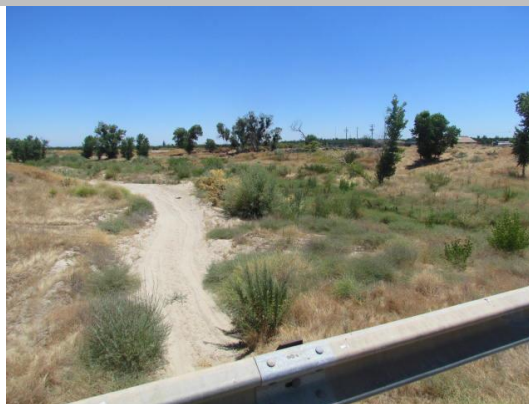
Looking upstream at the channel. (2018)

View of the vegetation on the channel looking upstream. Summer 2017

Looking upststream at channel from Road 13. (2016)

Inspector Comments: Established trees near bridge should be removed to prevent flow from being impeded

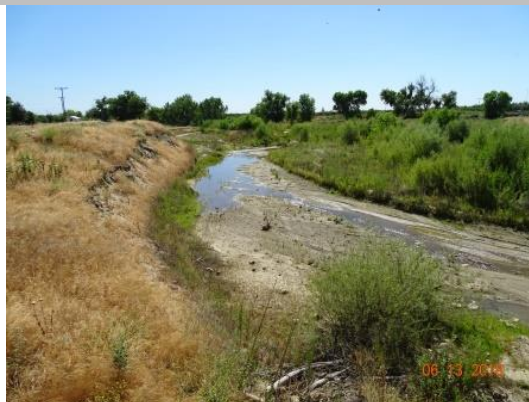
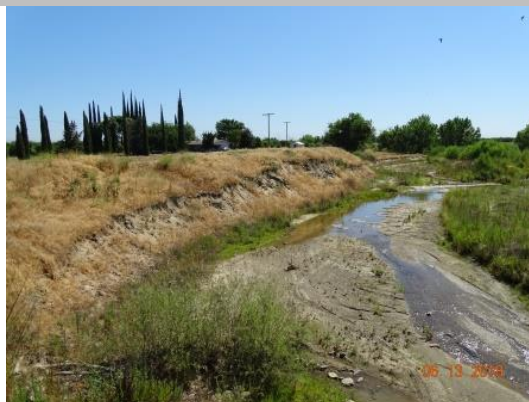
Inspector Comments: Large shoal with trees causing flow to erode the right bank.

View of shoal on the left side of the channel forcing flow towards the right bank and causing erosion (2018).

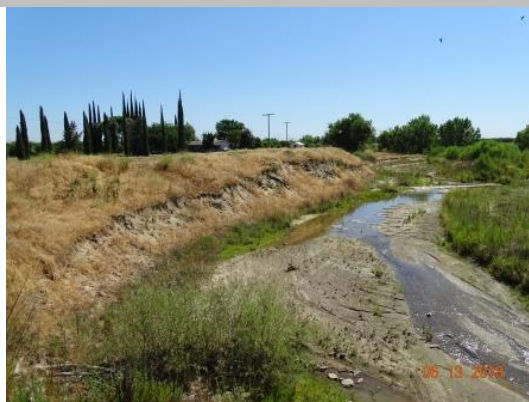
Rating **	M	Issue No.	24	GPS Lat/Long
Issue Type +	Ma	Location *		37.120400 °
Category	Rivers, Channels & Designated Flood			-120.310890 °
Item	Erosion / Bank Caving			
DWR ID	DWR_NA0011_38_c_2012_24			
Action/Comments				
Inspector Comments: Erosion on the right bank.

View upstream of erosion on the right bank. (2018)

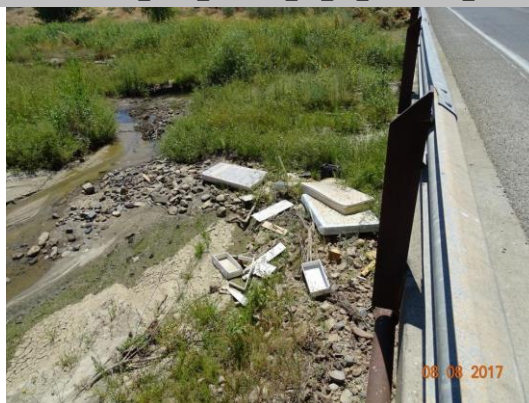
Inspector Comments: Some trash was found in the channel.

View of trash upstream end of the channel during 2017 inspection.

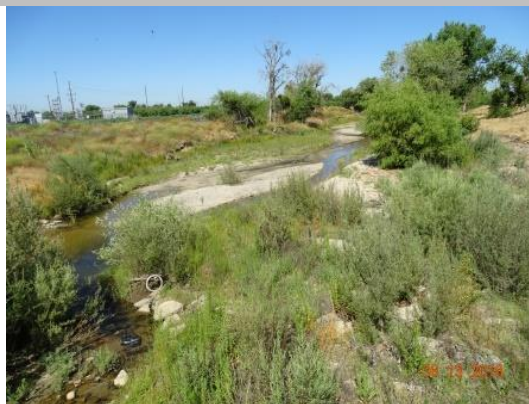
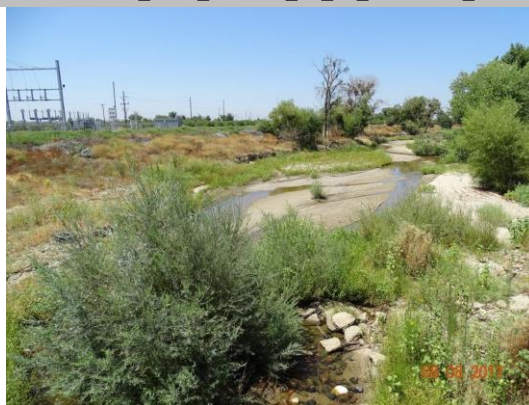
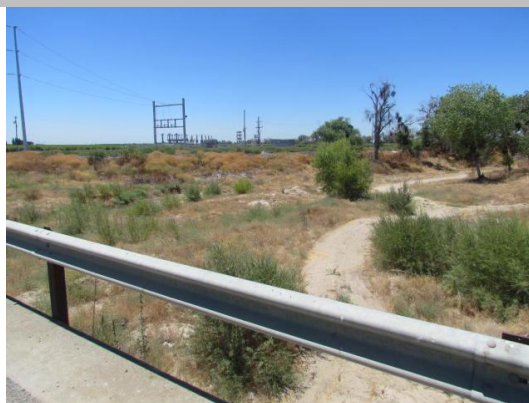
View of the channel looking downstream. (2018)

View of the vegetation looking downstream. Summer 2017

Looking downstream at channel from Rd. 13

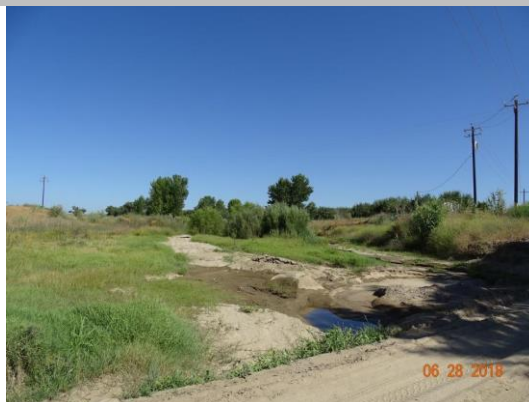
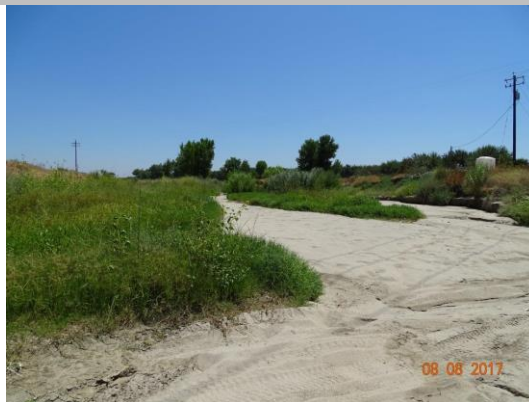
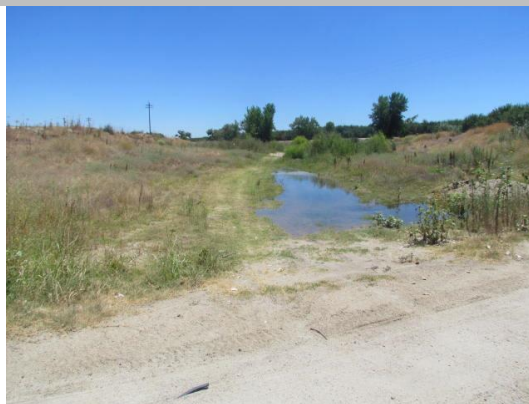
Check Point / View				
Rd 12 / Up				
Rating **	A	Issue No.	51	GPS Lat/Long
Issue Type +	Ma	Location *		37.113239 °
Category	Rivers, Channels & Designated Flood			-120.329124 °
Item	Vegetation & Obstructions			
DWR ID	DWR_NA0011_38_c_2012_51			
Action/Comments				
Inspector Comments: Some vegetation that does not impede flow in the channel.

View of the channel looking upstream (2018).

View of upstream of the channel. Summer 2017

Looking east (upstream) at channel from Road 12. (2016)

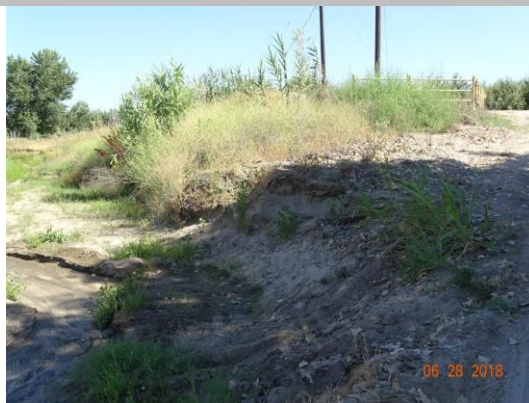
Rating **	A	Issue No.	44	GPS Lat/Long
Issue Type +	Ma	Location *		37.113239 °
Category	Rivers, Channels & Designated Flood			-120.329124 °
Item	Erosion / Bank Caving			
DWR ID	DWR_NA0011_38_c_2012_44			
Action/Comments				
Inspector Comments: Minor erosion occuring on the upstream left bank should be monitored.

Erosion on the upstream left bank (2018).

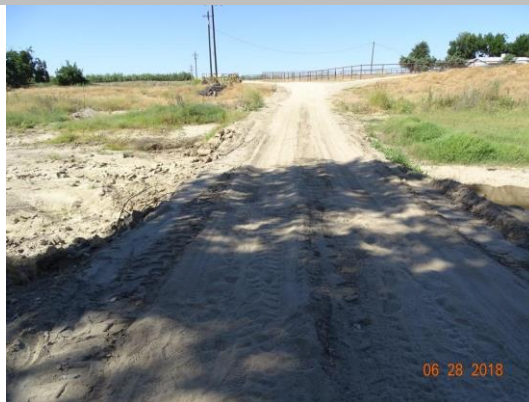
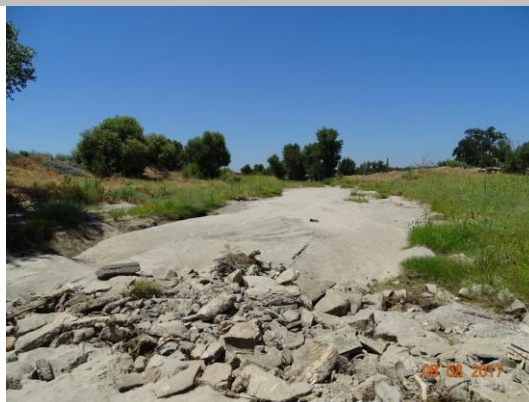
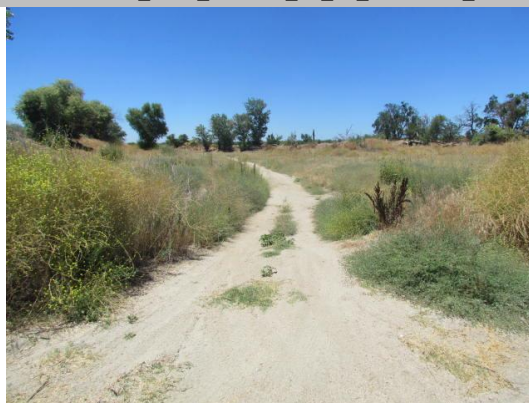
Inspector Comments: Minor vegetation that does not impede the flow in the channel.

Looking slightly downstream of the low water crossing (2018).

View of the channel looking downstream. Summer 2017

Looking west (downstream) at channel from Road 12. (2016)

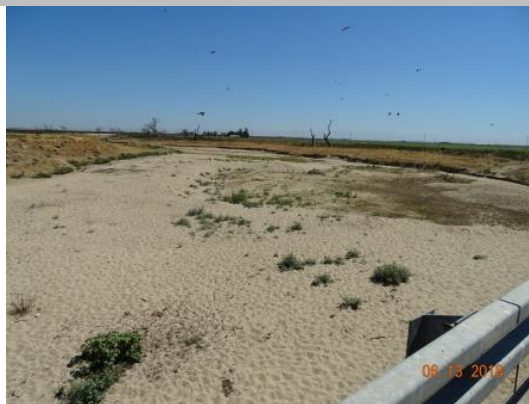
Photo 1 of 3 : CH\_2018\_NA0011\_38\_61\_20180614\_00049.jpg

View of the channel looking upstream. (2018)

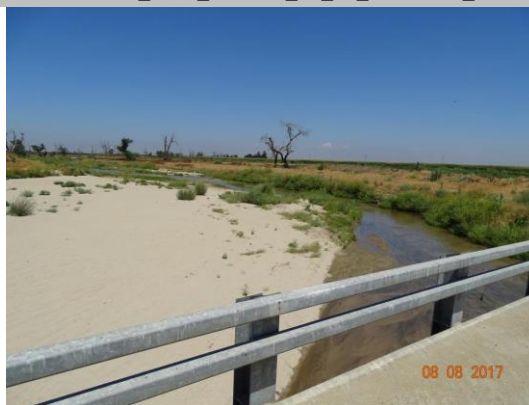
Photo 2 of 3 : CH\_2018\_NA0011\_38\_61\_20180529\_00018.jpg

View of the channel looking upstream. Summer 2017

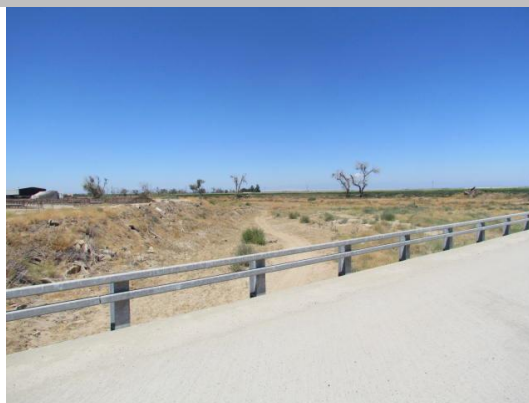
Photo 3 of 3 : CH\_2018\_NA0011\_38\_61\_20180529\_00019.jpg

Looking east (upstream) at channel from Avenue 23 1/2. (2016)

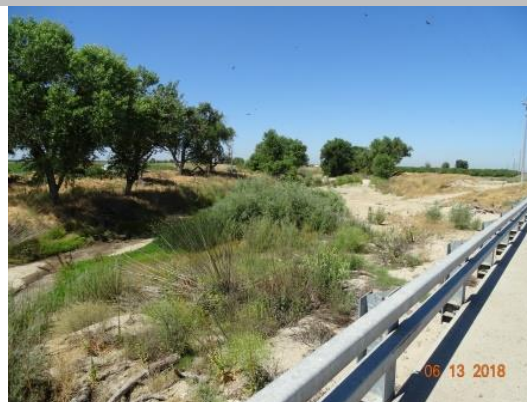
Photo 1 of 3 : CH\_2018\_NA0011\_38\_66\_20180614\_00050.jpg

Inspector Comments: Minimal vegetation, but arundo should be removed from the channel.

Looking downstream at the channel. (2018)

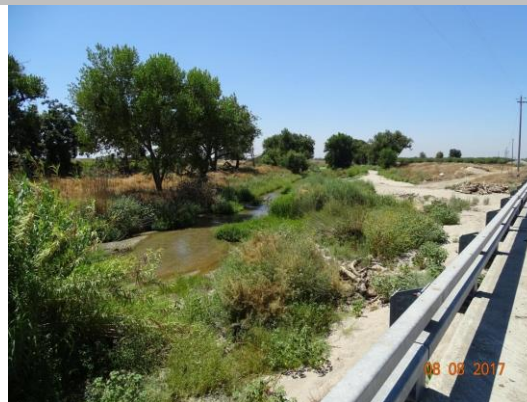
Photo 2 of 3 : CH\_2018\_NA0011\_38\_66\_20180529\_00020.jpg

View of the vegetation on the downstream of the channel. Summer 2017

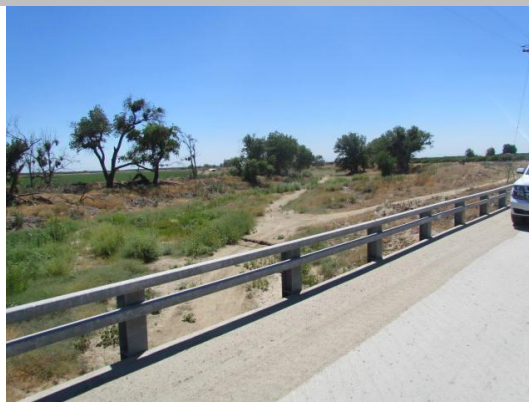
Photo 3 of 3 : CH\_2018\_NA0011\_38\_66\_20180529\_00021.jpg

Rating **	M	Issue No.	66 (cont)	GPS Lat/Long
Issue Type +	Ma	Location *		37.090668 °
Category	Rivers, Channels & Designated Flood			-120.352237 °
Item	Vegetation & Obstructions			
DWR ID	DWR_NA0011_38_c_2012_66			
Action/Comments				
Inspector Comments: Minimal vegetation, but arundo should be removed from the channel.

Looking west (downstream) at channel from Avenue 23 1/2. (2016)

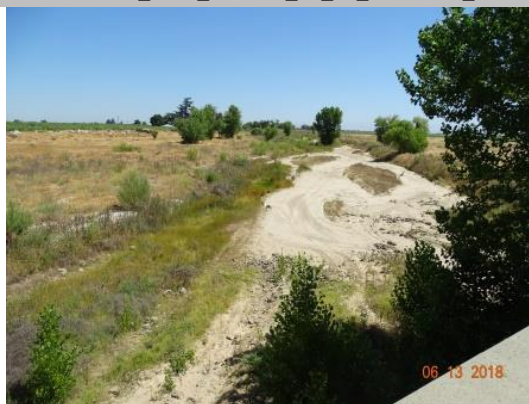
Photo 1 of 6 : CH\_2018\_NA0011\_38\_71\_20180614\_00052.jpg

Inspector Comments: Trees smaller than 4-inches in diameter at chest height should be removed.

Looking upstream at the channel. (2018)

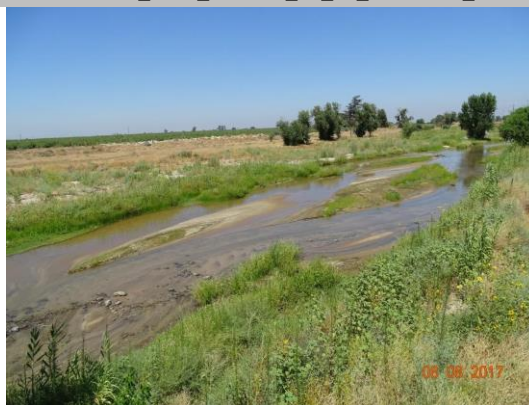
Photo 3 of 6 : CH\_2018\_NA0011\_38\_71\_20180529\_00022.jpg

View of the channel looking upstream. Summer 2017

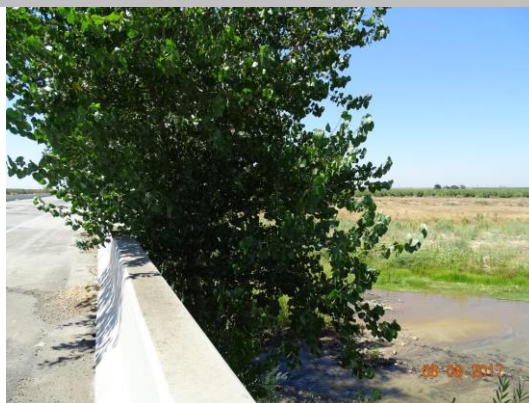
Photo 4 of 6 : CH\_2018\_NA0011\_38\_71\_20180529\_00024.jpg

View of a grown tree under the bridge. Summer 2017

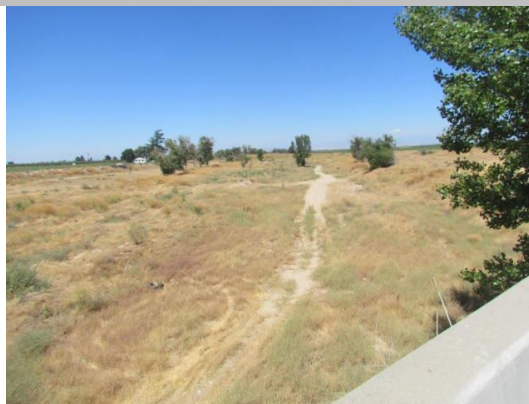
Photo 5 of 6 : CH\_2018\_NA0011\_38\_71\_20180529\_00023.jpg

Inspector Comments: Trees smaller than 4-inches in diameter at chest height should be removed.

Looking east (upstream) at channel from Hwy 152. (2016)

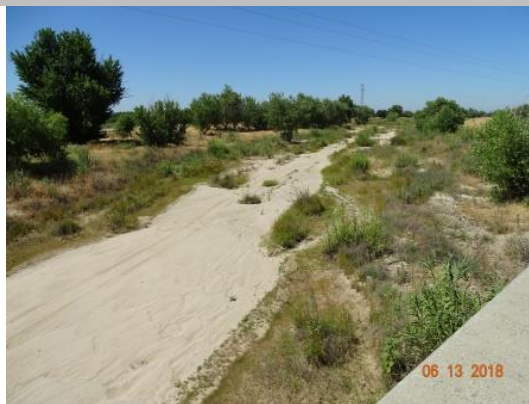
Photo 1 of 3 : CH\_2018\_NA0011\_38\_76\_20180614\_00051.jpg

Rating **	A	Issue No.	76	GPS Lat/Long
Issue Type +	Ma	Location *		37.083194 °
Category	Rivers, Channels & Designated Flood			-120.359943 °
Item	Vegetation & Obstructions			
DWR ID	DWR_NA0011_38_c_2012_76			
Action/Comments				
Inspector Comments: Minimal vegetation was found, but it does not appear to impede the flow in the channel.

Looking downstream at the channel. (2018)

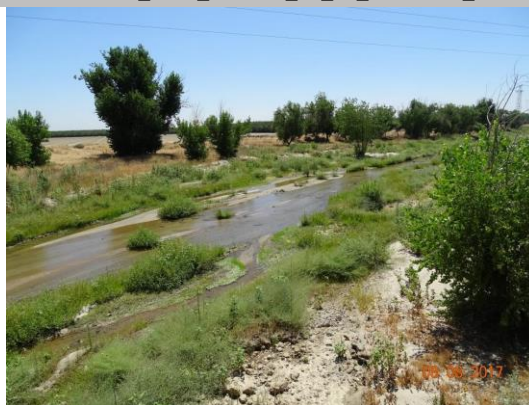
Photo 2 of 3 : CH\_2018\_NA0011\_38\_76\_20180529\_00026.jpg

View of the downstream of the channel. Summer 2017

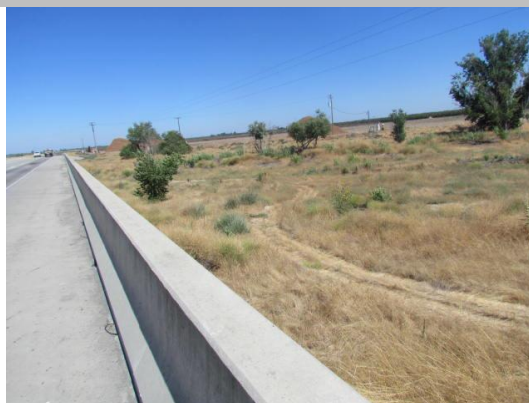
Photo 3 of 3 : CH\_2018\_NA0011\_38\_76\_20180529\_00027.jpg

Looking west (downstream) at channel from Hwy 152.

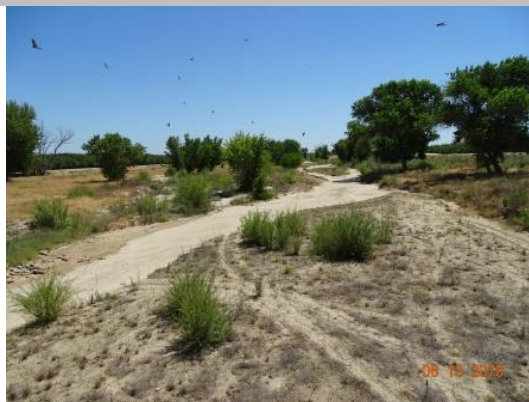
Photo 1 of 3 : CH\_2018\_NA0011\_38\_81\_20180614\_00054.jpg

Rating **	A	Issue No.	81	GPS Lat/Long
Issue Type +	Ma	Location *		37.077870 °
Category	Rivers, Channels & Designated Flood			-120.382770 °
Item	Vegetation & Obstructions			
DWR ID	DWR_NA0011_38_c_2012_81			
Action/Comments				
Inspector Comments: No vegetation or obstructions present to impede channel flow.

Looking upstream at the channel. (2018)

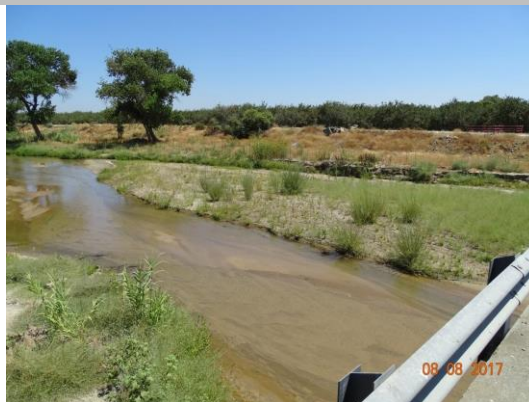
Photo 2 of 3 : CH\_2018\_NA0011\_38\_81\_20180529\_00028.jpg

View of the channel looking upstream. Summer 2017

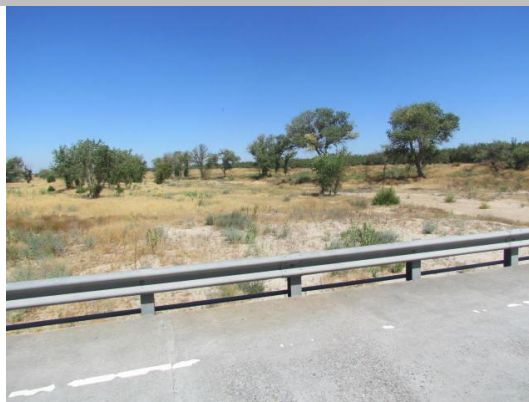
Photo 3 of 3 : CH\_2018\_NA0011\_38\_81\_20180529\_00029.jpg

Rating **	A	Issue No.	81 (cont)	GPS Lat/Long
Issue Type +	Ma	Location *		37.077870 °
Category	Rivers, Channels & Designated Flood			-120.382770 °
Item	Vegetation & Obstructions			
DWR ID	DWR_NA0011_38_c_2012_81			
Action/Comments				
Inspector Comments: No vegetation or obstructions present to impede channel flow.

Looking east (upstream) at channel from Road 9. (2016)

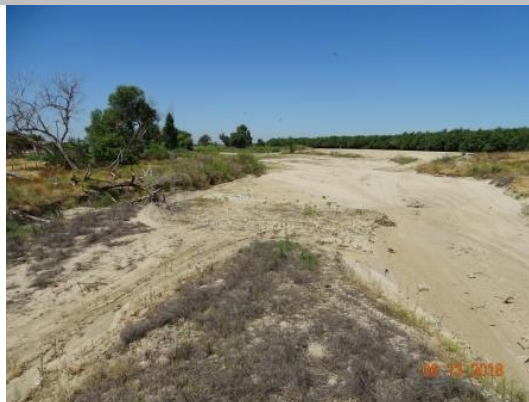
Photo 1 of 3 : CH\_2018\_NA0011\_38\_86\_20180614\_00055.jpg

View of the channel looking downstream. (2018)

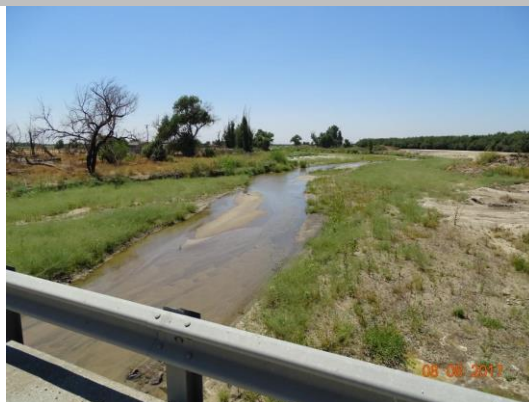
Photo 2 of 3 : CH\_2018\_NA0011\_38\_86\_20180529\_00030.jpg

View of the channel looking downstream. Summer 2017

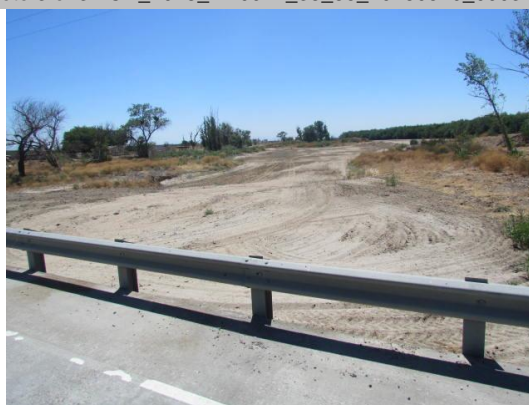
Photo 3 of 3 : CH\_2018\_NA0011\_38\_86\_20180529\_00031.jpg

Looking west (downstream) at channel from Road 9. (2016)

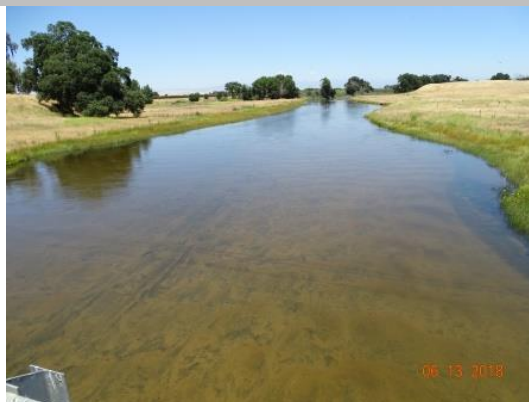
Photo 1 of 3 : CH\_2018\_NA0011\_39\_1\_20180615\_00052.jpg

Looking upstream at the channel. (2018)

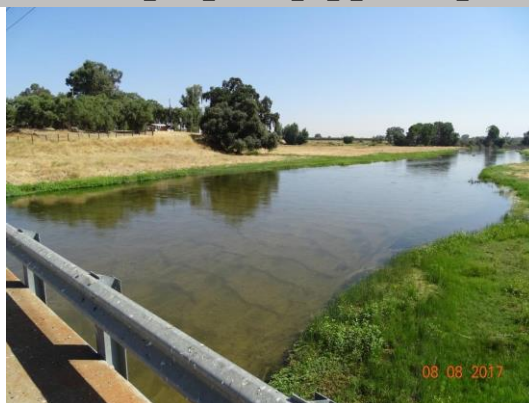
Photo 2 of 3 : CH\_2018\_NA0011\_39\_1\_20180601\_00001.jpg

View of the channel looking upstream during 2017 inspection.

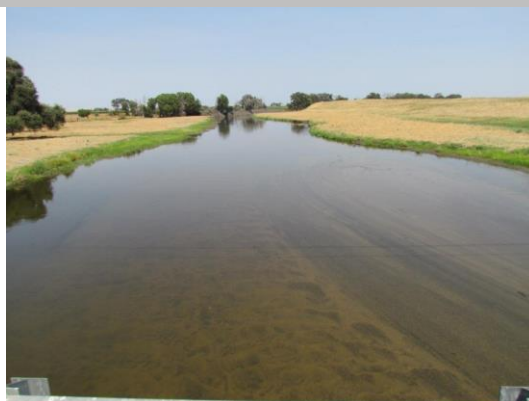
Photo 3 of 3 : CH\_2018\_NA0011\_39\_1\_20180601\_00002.jpg

Berenda Slough looking upstream from Santa Fe Crossing. Channel clear of vegetation.

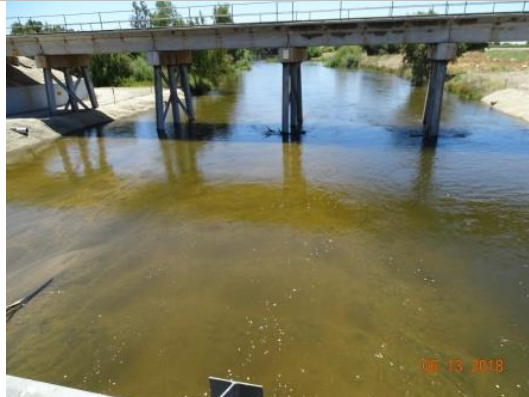
Photo 1 of 3 : CH\_2018\_NA0011\_39\_6\_20180615\_00053.jpg

Inspector Comments: No vegetation in channel downstream from bridge crossing.

Looking downstream at the channel. (2018)

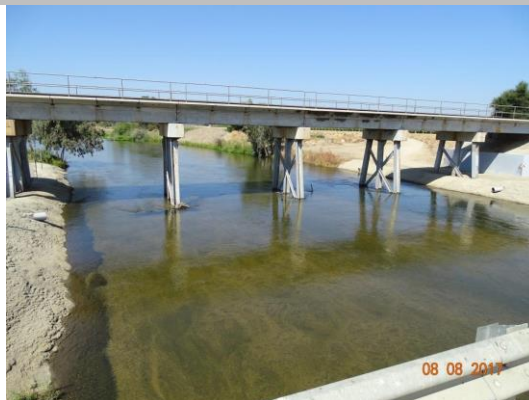
Photo 2 of 3 : CH\_2018\_NA0011\_39\_6\_20180601\_00003.jpg

View of the channel looking downstream. Summer 2017

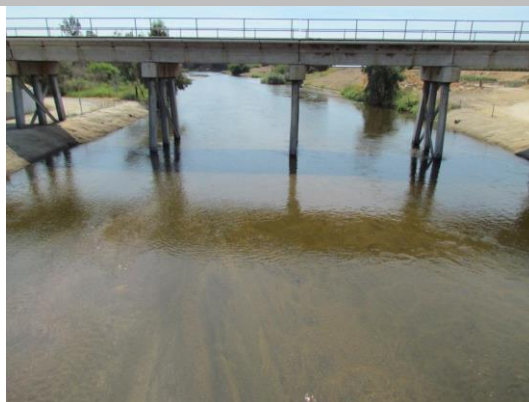
Photo 3 of 3 : CH\_2018\_NA0011\_39\_6\_20180601\_00004.jpg

Inspector Comments: No vegetation in channel downstream from bridge crossing.

Looking downstream from Santa Fe Bridge crossing.

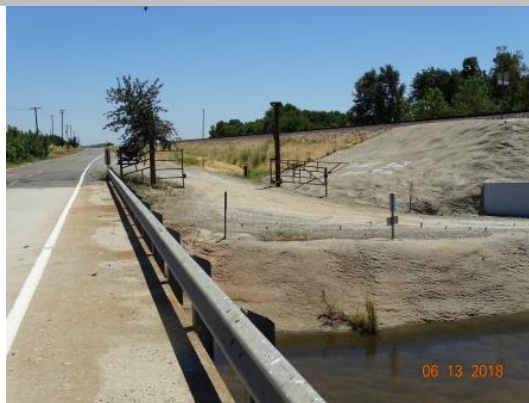
Photo 2 of 5 : CH\_2018\_NA0011\_39\_10\_20180615\_00056.jpg

Gate on the downstream left bank. (2018)

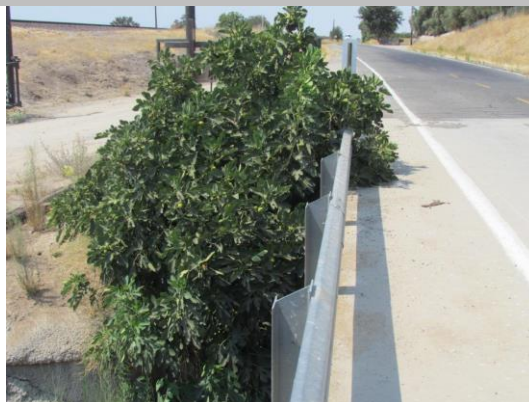
Photo 3 of 5 : CH\_2018\_NA0011\_39\_10\_20180601\_00005.jpg

Inspector Comments: There is a fig tree on the right bank downstream of bridge along with a pipe gate and barricade. Across the channel on the left bank there is a pipe gate and pipe barricade, no known CVFPB Permit on file.

Fig tree present downstream right bank of the Berenda slough. Need to be removed.

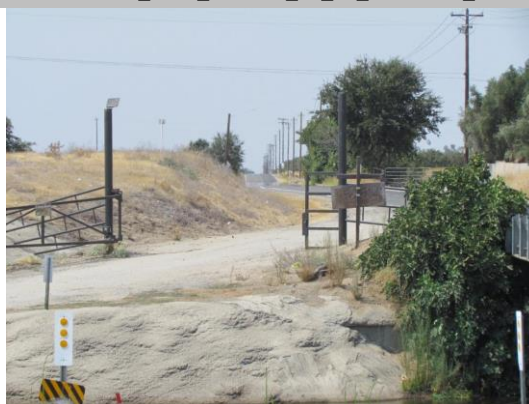
Photo 4 of 5 : CH\_2018\_NA0011\_39\_10\_20180601\_00006.jpg

Pipe gate and barricade present on the right bank downstream side of Santa Fe bridge.

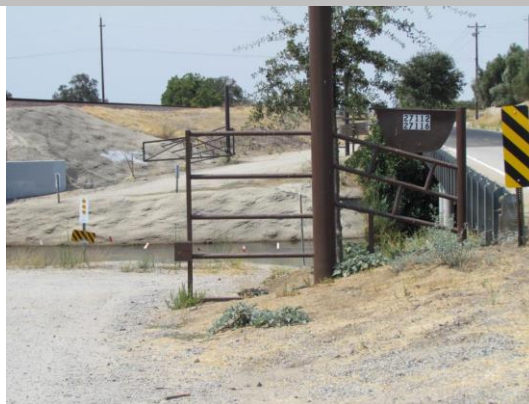
Photo 5 of 5 : CH\_2018\_NA0011\_39\_10\_20180601\_00007.jpg

Inspector Comments: There is a fig tree on the right bank downstream of bridge along with a pipe gate and barricade. Across the channel on the left bank there is a pipe gate and pipe barricade, no known CVFPB Permit on file.

Pipe gate and barricade present on the left bank downstream side of Santa Fe bridge.

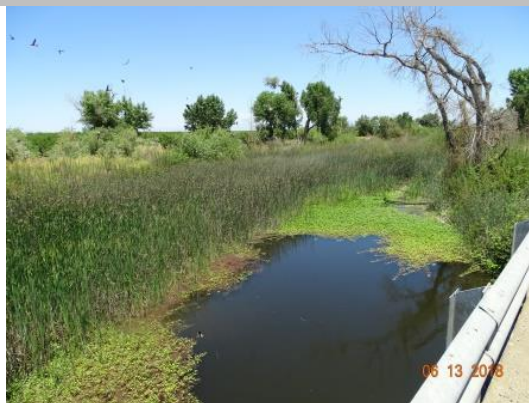
Photo 1 of 3 : CH\_2018\_NA0011\_39\_11\_20180615\_00057.jpg

Inspector Comments: Cattails, willow trees, and other vegetation in channel all need to be controlled.

Looking upstream at the channel. (2018)

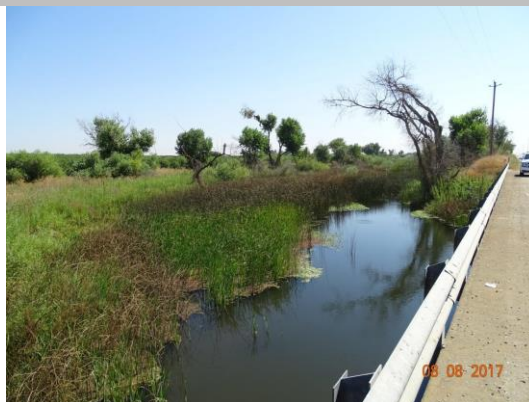
Photo 2 of 3 : CH\_2018\_NA0011\_39\_11\_20180601\_00008.jpg

Inspector Comments: Cattails, willow trees, and other vegetation in channel all need to be controlled.

View of the vegetation on the upstream of the channel during 2017 inspection.

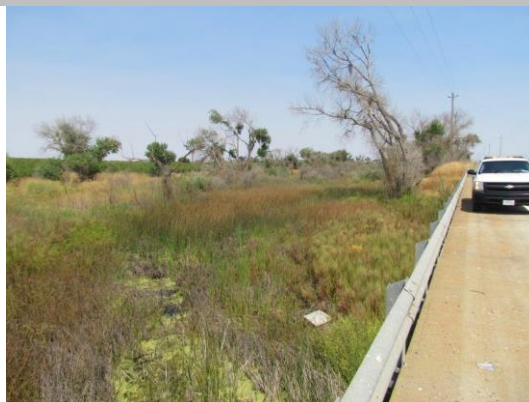
Photo 3 of 3 : CH\_2018\_NA0011\_39\_11\_20180601\_00009.jpg

Berenda Slough looking upstream from the Avenue 26 bridge crossing. Control the growth inside the channel.

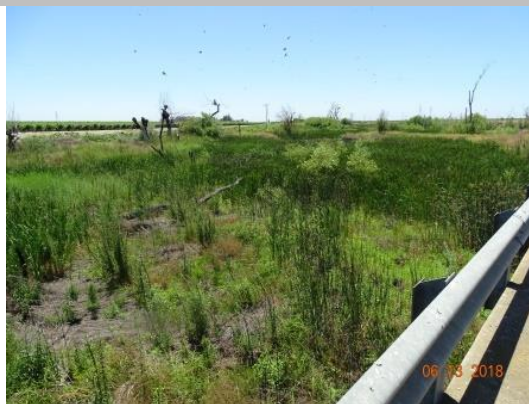
Photo 1 of 3 : CH\_2018\_NA0011\_39\_16\_20180615\_00058.jpg

Looking downstream at the channel. (2018)

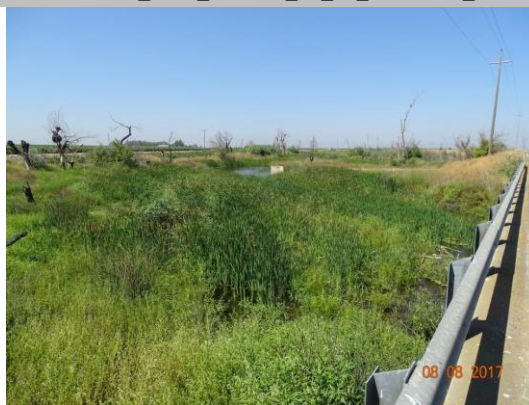
Photo 2 of 3 : CH\_2018\_NA0011\_39\_16\_20180601\_00010.jpg

View of the vegetation growth on the downstream of the channel.  
Summer 2017

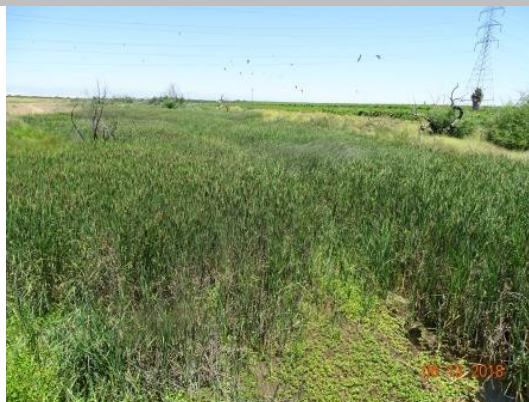
Photo 1 of 3 : CH\_2018\_NA0011\_39\_21\_20180615\_00059.jpg

Check Point / View				
Rd 19 / Up				
Rating **	A	Issue No.	21	GPS Lat/Long
Issue Type +	Ma	Location *		37.122250 °
Category	Rivers, Channels & Designated Flood			-120.202280 °
Item	Vegetation & Obstructions			
DWR ID	DWR_NA0011_39_c_2016_21			
Action/Comments				
Inspector Comments: Channel thick with cattails and should be maintained, but flow does not appear to be impeded at this time.

Looking upstream at the channel. (2018)

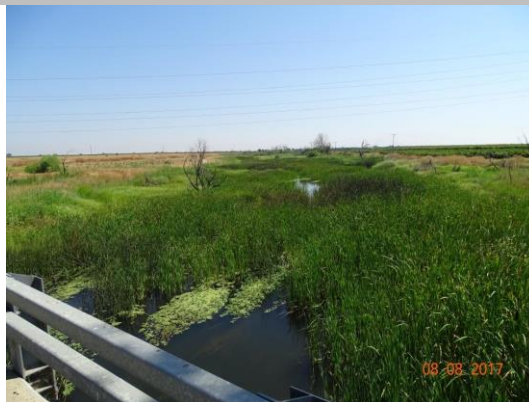
Photo 2 of 3 : CH\_2018\_NA0011\_39\_21\_20180601\_00012.jpg

View of the vegetation on the upstream of the channel. Summer 2017

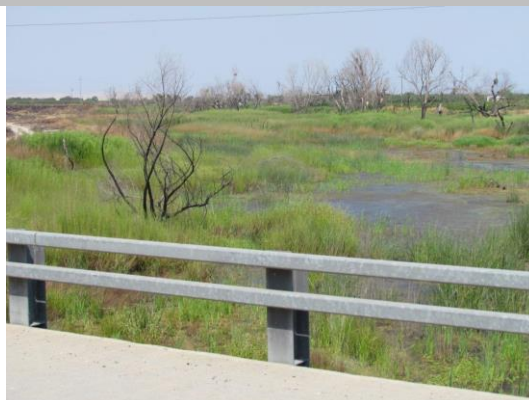
Photo 3 of 3 : CH\_2018\_NA0011\_39\_21\_20180601\_00013.jpg

Rating **	A	Issue No.	21 (cont)	GPS Lat/Long
Issue Type +	Ma	Location *		37.122250 °
Category	Rivers, Channels & Designated Flood			-120.202280 °
Item	Vegetation & Obstructions			
DWR ID	DWR_NA0011_39_c_2016_21			
Action/Comments				
Inspector Comments: Channel thick with cattails and should be maintained, but flow does not appear to be impeded at this time.

Looking upstream at the Berenda Slough from Road 19 bridge crossing.

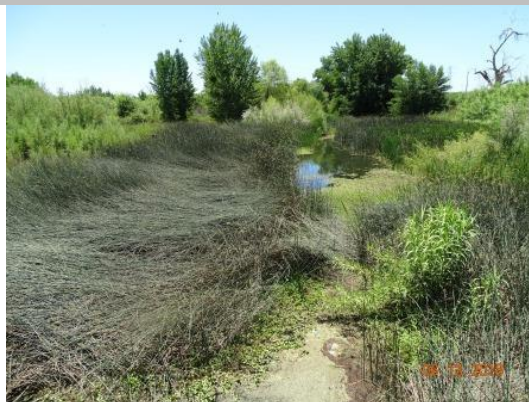
Photo 1 of 6 : CH\_2018\_NA0011\_39\_26\_20180615\_00060.jpg

Check Point / View				
<b>Rd 19 / Down</b>				
Rating **	M	Issue No.	26	GPS Lat/Long
Issue Type +	Ma	Location *		37.122250 °
Category	Rivers, Channels & Designated Flood			-120.202280 °
Item	Vegetation & Obstructions			
DWR ID	DWR_NA0011_39_c_2016_26			
Action/Comments				
Inspector Comments: Large tree on the right bank could and cattails could obstruct flow.

Downstream view of the channel. (2018)

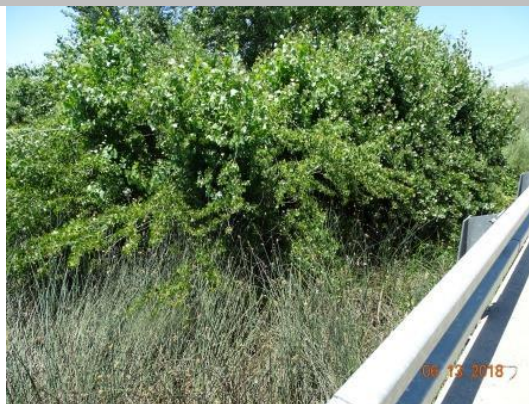
Photo 2 of 6 : CH\_2018\_NA0011\_39\_26\_20180615\_00062.jpg

Downstream view of large tree in the channel. (2018)

Rating **	M	Issue No.	26 (cont)	GPS Lat/Long
Issue Type +	Ma	Location *		37.122250 °
Category	Rivers, Channels & Designated Flood			-120.202280 °
Item	Vegetation & Obstructions			
DWR ID	DWR_NA0011_39_c_2016_26			
Action/Comments				
Inspector Comments: Large tree on the right bank could and cattails could obstruct flow.

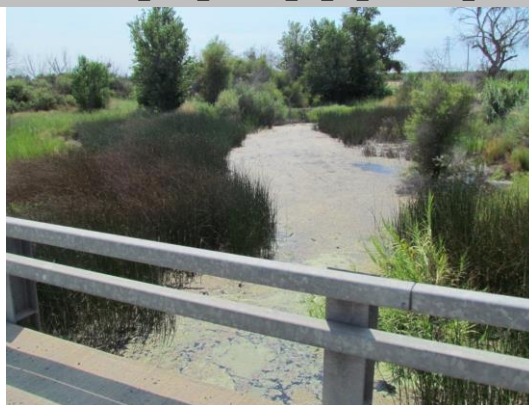
Photo 3 of 6 : CH\_2018\_NA0011\_39\_26\_20180601\_00015.jpg

Looking downstream from Road 19 bridge crossing at Berenda Slough.

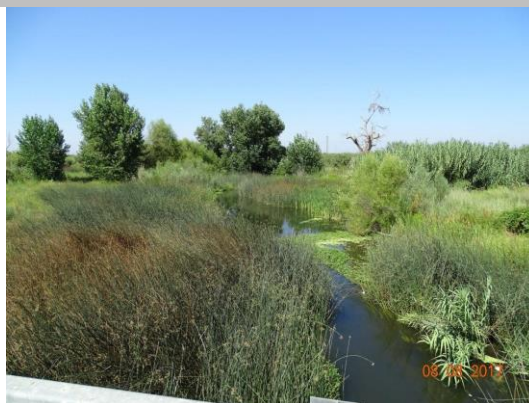
Photo 4 of 6 : CH\_2018\_NA0011\_39\_26\_20180601\_00014.jpg

View of the vegetation on the downstream of the channel. Summer 2017

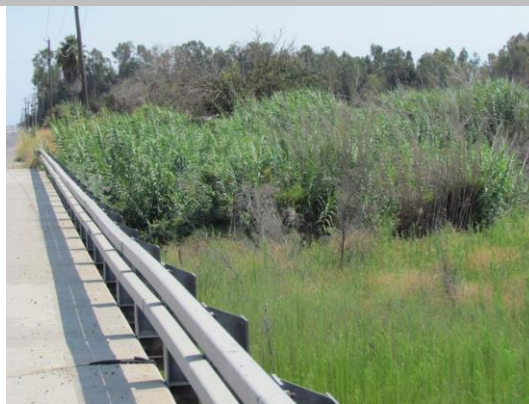
Photo 5 of 6 : CH\_2018\_NA0011\_39\_26\_20180601\_00016.jpg

Looking downstream leftbank of bridge there is unwanted wild growth of willow trees, Arundo, and other vegetation.

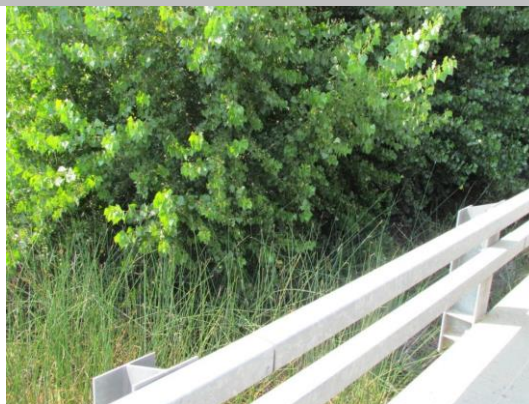
Photo 6 of 6 : CH\_2018\_NA0011\_39\_26\_20180601\_00017.jpg

Brush present on the right bank of Road 19 downstream of bridge.

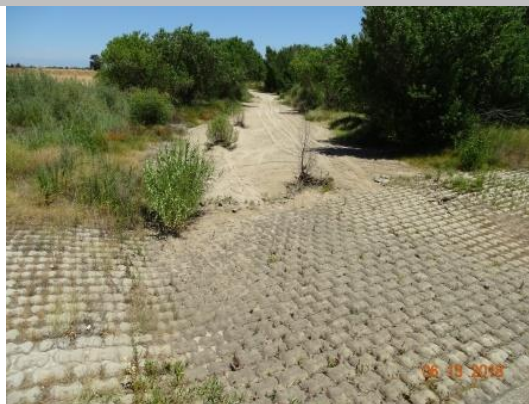
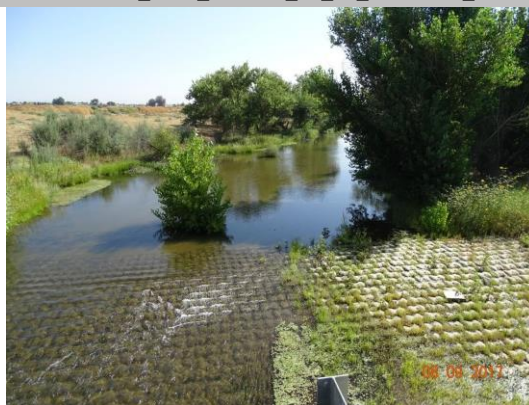
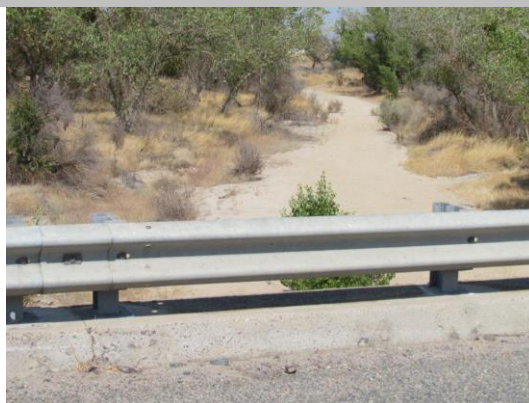
Rating **	A	Issue No.	31	GPS Lat/Long
Issue Type +	Ma	Location *		37.106310 °
Category	Rivers, Channels & Designated Flood			-120.234140 °
Item	Vegetation & Obstructions			
DWR ID	DWR_NA0011_39_c_2016_31			
Action/Comments				
Inspector Comments: Small amounts of vegetation that does not appear to impede flow in the channel.

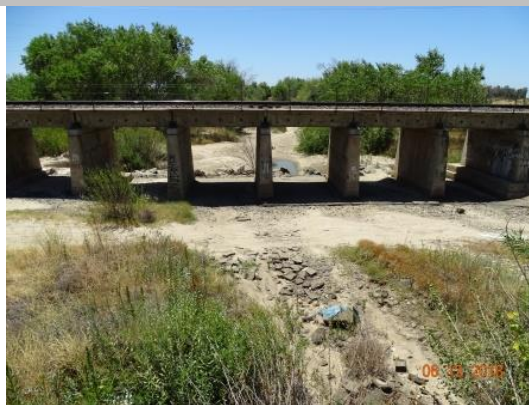
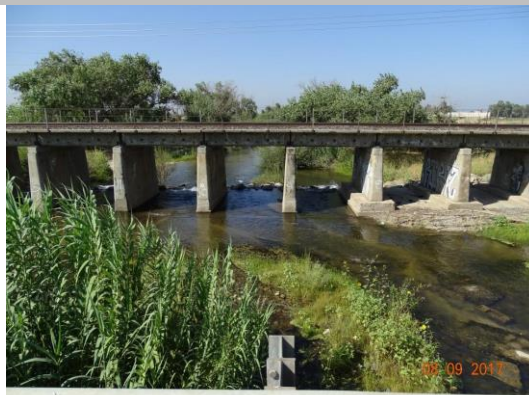
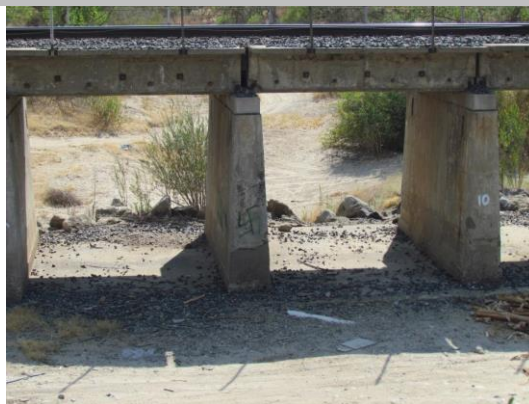
Check Point / View				
Chowchilla Blvd / Down				
Rating **	A	Issue No.	36	GPS Lat/Long
Issue Type +	Ma	Location *		37.106310 °
Category	Rivers, Channels & Designated Flood			-120.234140 °
Item	Vegetation & Obstructions			
DWR ID	DWR_NA0011_39_c_2016_36			
Action/Comments				
Inspector Comments: Arundo has started growing in the channel and it could impede flow in the future.

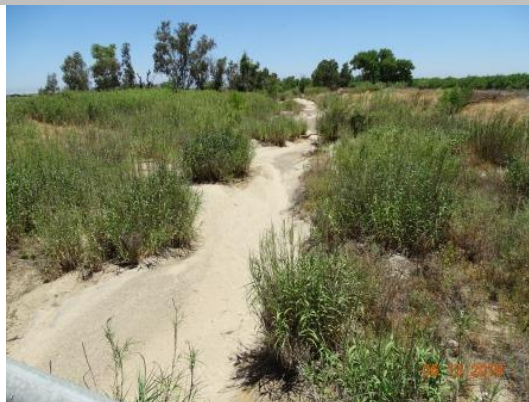
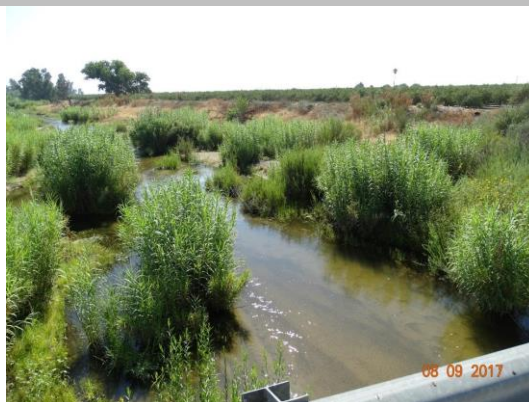
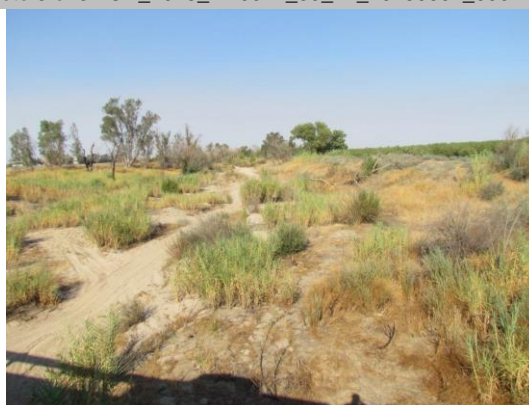
Rating **	M	Issue No.	41	GPS Lat/Long
Issue Type +	Ma	Location *		37.099721 °
Category	Rivers, Channels & Designated Flood			-120.256744 °
Item	Vegetation & Obstructions			
DWR ID	DWR_NA0011_39_c_2016_41			
Action/Comments				
Inspector Comments: There are a significant number of arundo in the channel.
